# FIRE RISK ASSESSMENT

## Hartwell Court

| <b>Assessment Type:</b> | Type 1 — Common parts only (non-destructive) |
| <b>Inspection Date:</b> | 25 March 2026 |

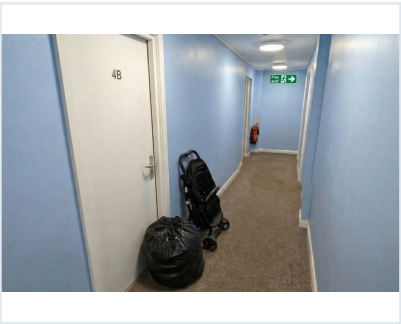
Photo evidence for Sources of Fuel

On the fifth floor corridor outside flat 28, a pushchair and a black bin bag were observed obstructing the communal passage. Additionally, on the sixth floor corridor adjacent to the lift doors, three to four cardboard boxes were stacked against the wall, creating a potential fire load and obstruction in the escape route. The storage of personal items in common areas was noted to be non-compliant with fire safety standards.

The responsible person must remove the pushchair, bin bag, and cardboard boxes from the communal corridors immediately and implement strict enforcement of the no-storage policy in all common parts.

| Ref | Issue | Remedial Action | Priority | Timescale |
|---|---|---|---|---|
| <b>A2.1</b> | On the fifth floor corridor outside flat 28, a pushchair and a black bin bag were observed obstructing the communal passage. Additionally, on the sixth floor corridor adjacent to the lift doors, three to four cardboard boxes were stacked against the wall, creating a potential fire load and obstruction in the escape route. The storage of personal items in common areas was noted to be non-compliant with fire safety standards. | The responsible person must remove the pushchair, bin bag, and cardboard boxes from the communal corridors immediately and implement strict enforcement of the no-storage policy in all common parts. | <b>P1</b> | 24 hours |

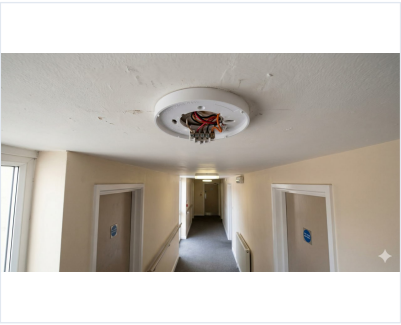
Photo evidence for Fire Detection and Warning

The fire alarm control panel located in the ground floor entrance lobby was found to be in normal operating condition with no fault indications present. Heat detectors were observed to be installed within the lobbies on each floor. The system maintenance was confirmed to be undertaken by ProTec Fire, with the most recent service certificate dated June 2025 displayed adjacent to the panel. The building contains seven storeys but smoke detectors were tested only on floors 2, 5, and 8, which is inconsistent as the building has only seven floors. Manual call points were present at each staircase landing and had intact glass without any visible damage. However, verification of smoke detector functionality was incomplete due to testing on a non-existent eighth floor. On the ground floor rear corridor leading to the bin store, the smoke detector head is absent, with only the mounting base plate remaining attached to the ceiling. This results in a lack of fire detection in that section, compromising the overall alarm coverage.

- The responsible person must ensure that smoke detectors on every floor, including floors not yet tested, are functionally verified by a competent fire alarm engineer and records updated accordingly.
- The responsible person must engage a competent fire alarm engineer to install a replacement detector head on the existing base plate in the ground floor rear corridor.

| Ref | Issue | Remedial Action | Priority | Timescale |
|---|---|---|---|---|
| D1.1 | <p>The fire detection and warning system comprises a fire alarm control panel located in the ground floor entrance lobby, which is in normal operating condition with no fault indications, and heat detectors installed in the lobbies on each floor; maintenance is undertaken by ProTec Fire, with the most recent service certificate dated June 2025 displayed adjacent to the panel. The building is seven storeys in height, but smoke detectors were tested on floors 2, 5 and 8, which is inconsistent as there is no eighth floor, indicating incomplete verification of detector functionality across all levels; manual call points are located at each staircase landing and remain intact with undamaged glass. On the ground floor rear corridor leading to the bin store, the smoke detector head is absent, leaving only the mounting base plate attached to the ceiling, resulting in a lack of fire detection in that area and compromising overall alarm coverage.</p> | <p>The responsible person must ensure that smoke detectors on every floor, including floors not yet tested, are functionally verified by a competent fire alarm engineer, and records updated accordingly. The responsible person must engage a competent fire alarm engineer to install a replacement detector head on the existing base plate in the ground floor rear corridor.</p> | P1 | 24 hours |

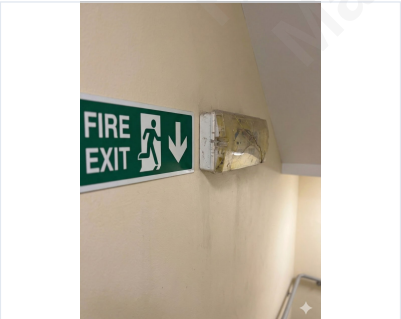
Photo evidence for Emergency Lighting

The emergency lighting unit located in the floor 6 corridor near the lift lobby failed to activate during the function test, as pressing the test button produced no response. Additionally, the emergency light unit on the floor 3 staircase landing was found to have a cracked diffuser, likely caused by an impact. It requires inspection to confirm functionality and the damaged cover should be replaced promptly.

The responsible person must engage a qualified electrician to repair the non-functioning emergency light near the lift lobby and replace the cracked diffuser cover on the staircase landing after confirming the unit's operational status.

| Ref | Issue | Remedial Action | Priority | Timescale |
|---|---|---|---|---|
| D3.1 | The emergency lighting unit located in the floor 6 corridor near the lift lobby failed to activate during the function test, as pressing the test button produced no response. Additionally, the emergency light unit on the floor 3 staircase landing was found to have a cracked diffuser, likely caused by an impact. It requires inspection to confirm functionality and the damaged cover should be replaced promptly. | The responsible person must engage a qualified electrician to repair the non-functioning emergency light near the lift lobby and replace the cracked diffuser cover on the staircase landing after confirming the unit's operational status. | P1 | 24 hours |
