# FIRE RISK ASSESSMENT

## Hartwell Court

| <b>Assessment Type:</b> | Type 1 — Common parts only (non-destructive) |
| <b>Inspection Date:</b> | 25 March 2026 |

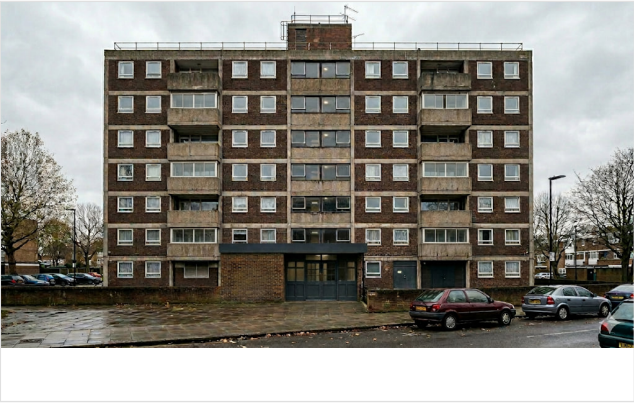
Main Building Photo

Hartwell Court is a 7-storey purpose-built block of 42 flats, constructed in 1974, with an overall building height of 21.5 metres. The building has a concrete frame with concrete floors and brick exterior walls, featuring concrete spandrel panels below windows; there is no combustible cladding or ACM present. Access to the flats, six per floor off a common corridor, is via a single lobbied staircase and two passenger lifts; the evacuation strategy is Stay Put. The ground floor houses an entrance lobby, plant rooms, electrical intake, bin store, and caretaker's office. Most flats benefit from recessed concrete balconies, and a flat roof includes a lift motor room at roof level.
